APOLLO EXPERIENCE REPORT - CREW STATION INTEGRATION

Volume I - Crew Station
Design and Development

Louis D. Allen and Dale A. Nussman

Lyndon B. Johnson Space Center

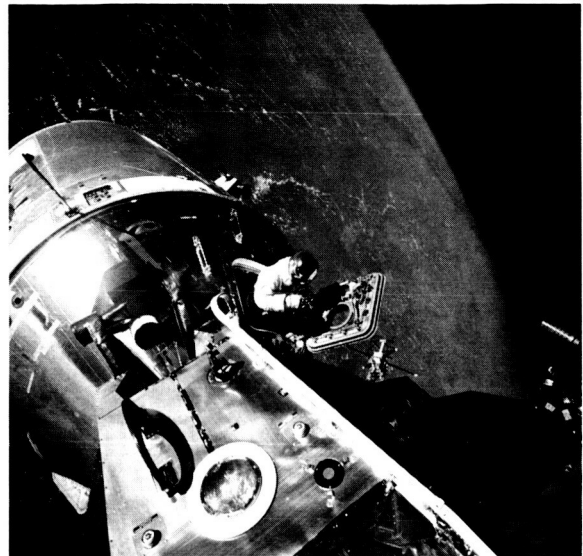
Figure 6.- The Apollo 9 CM and LM in the docked configuration.

In November 1962, a contract was awarded for the design and development of the LM. The following year, a full-scale LM mockup was constructed that contained a crew station built and outfitted to comply with the program requirements. A model of the LM (circa 1962) is illustrated in figure 3. By the end of 1962, basic mission and crew station operations had been defined, basic spacecraft and crew equipment had been identified, and the external and internal geometries of the CM and the LM had evolved to configurations not radically different from those of the "as flown" spacecraft (figs. 4 to 6).

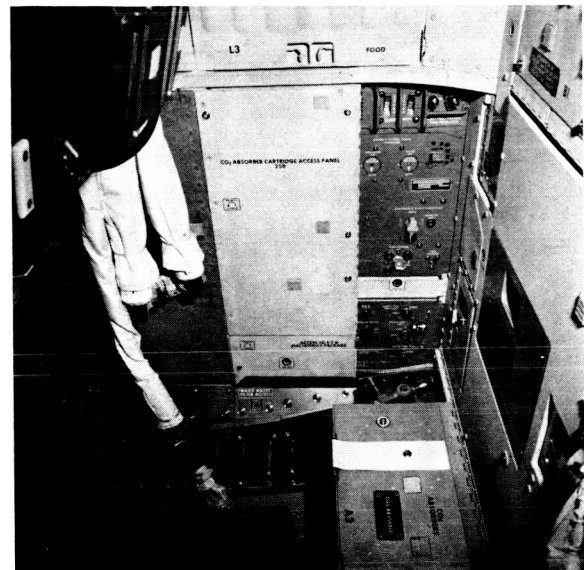
Figure 10.- The CM interior – left-hand equipment bay (ECS equipment area).

Major equipment contained within the crew compartments of the CM (figs. 7 to 14) and the LM (figs. 15 to 22) included controls and displays for the operation of the spacecraft and spacecraft systems, restraint harness assemblies, window shades, crew equipment, food and water, and waste management provisions. Survival equipment and couches also were provided in the CM. The CM had an interior volume of 10.4 cubic meters (366 cubic feet). Interior bays, lockers, couches, and crewmen accounted for 4.4 cubic meters (156 cubic feet); therefore, a total free volume of 6 cubic meters (210 cubic feet), or 2 cubic meters (70 cubic feet) per crewman, remained. The total interior volume of the LM crew compartment was 7 cubic meters (235 cubic feet). Approximately two-thirds of this volume was in the 2.3-meter (92 inch) diameter forward cabin section, with the remaining volume in the 1.4-meter (54 inch) midsection. The LM volumetric values closely approximate two-thirds of the values specified for the

The numerous loose items of personal and systems equipment in the CM and the LM were stowed in compartments, lockers, and bags (figs. 7 to 22). Stowage compartments were built into the interior walls of both the CM and the LM. Equipment was placed in "cushions" and inserted into these compartments. Removable aluminum lockers with preinstalled cushions also were used in both vehicles. The stowage compartment and locker doors had retention mechanisms that could be actuated with one hand (an aid in zero-g operations). A variety of stowage bags also was used in both vehicles. The stowage containers were labeled for identification and as a location aid. In the CM, containers were numbered consecutively from fore to aft; the numbers were prefixed with a letter designator of the bay. For example, right-hand equipment bay compartments were labeled R1 to R13. In the LM, stowage areas and contents were identified by descriptive labels. Letter designators were not necessary in the LM because the number of stowage items and configurations was considerably less than that in the CM.

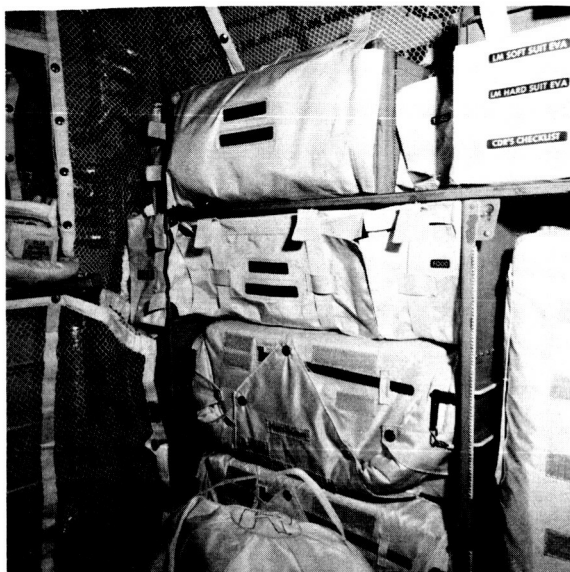
Figure 19.- The LM interior – looking aft and right (stowed equipment area).
